CRYSTAL DAM

NDS ID NO. PA-00677

5  
PHASE I INSPECTION REPORT  
NATIONAL DAM INSPECTION PROGRAM

AUGUST 1978

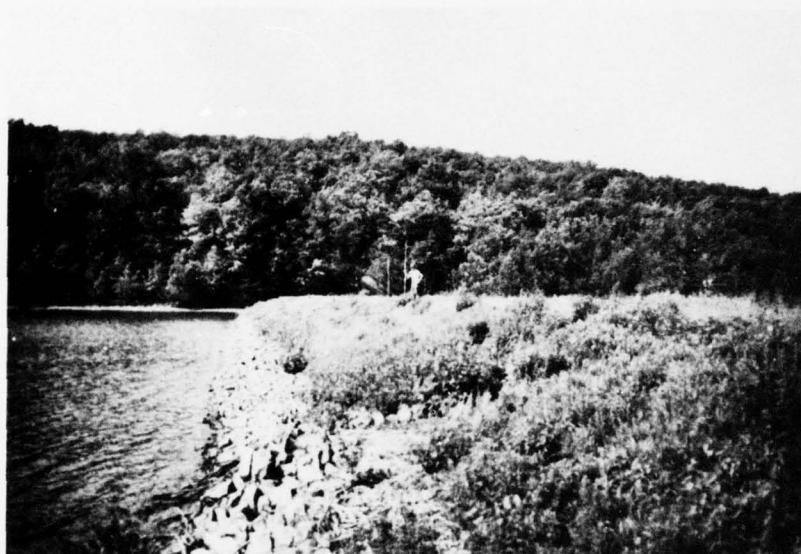
(2) The hand-placed riprap on the upstream slope of the embankment was intact to the top of the dam. The riprap was in good condition except for a growth of ferns and light brush that extended from normal pool level to the top of the dam (Photograph A). Larger brush had apparently been cut earlier this year.

A. Upstream Slope of Embankment.

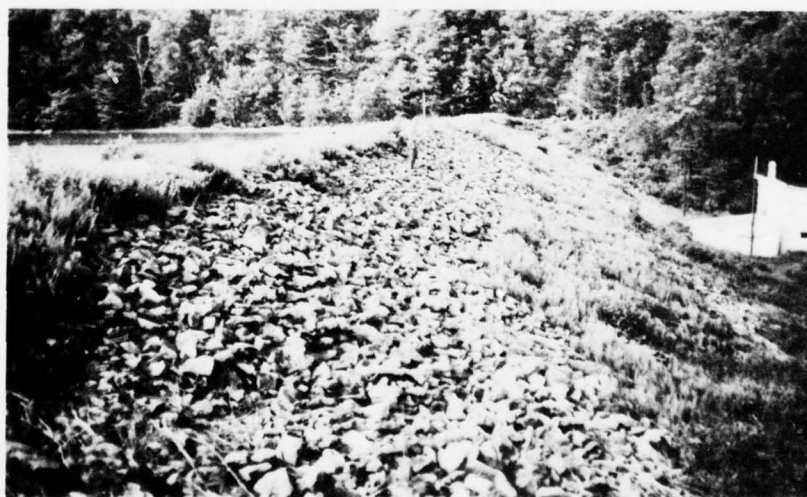
B. Downstream Slope of Embankment.

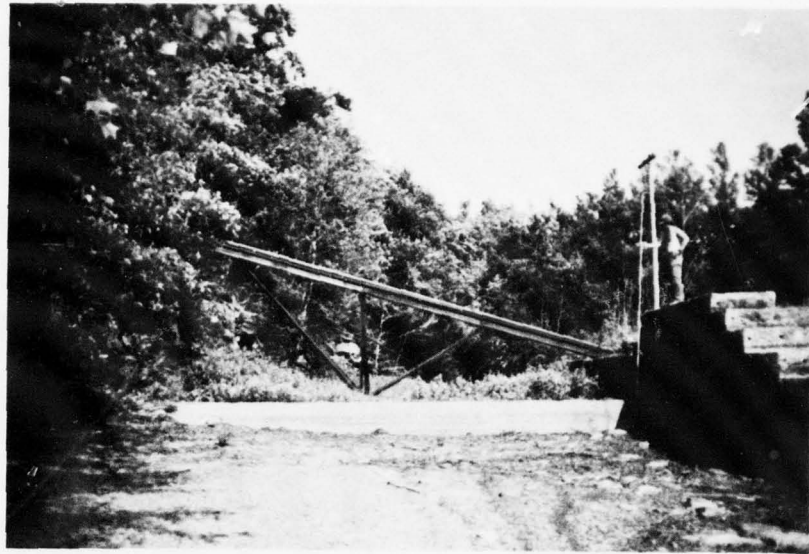
(1) Left Spillway. The approach channel to the left spillway was clear and had no apparent deficiencies. The concrete weir appeared to be in good condition, and no deficiencies were observed for the stone masonry wall at the left end of the embankment (Photograph C). Immediately downstream from the spillway weir is a support for a pipe bridge that carries an 8-inch diameter pressure line across the left spillway (Photograph C). The discharge channel in this area also had substantial amounts of debris, and considerable brush was growing in the stone lining that covers this portion of the channel. Beyond the stone-lined portion of the discharge channel, the discharge channel is excavated into rock. The right side of the channel is bounded by a dry masonry wall and the left side is bounded by the left hillside. Some trees up to 4 inches in diameter were growing in the fractures in the rock (Photograph G). A small bridge is located across the downstream end of the left spillway discharge channel.

C. Left Spillway — View from Upstream.

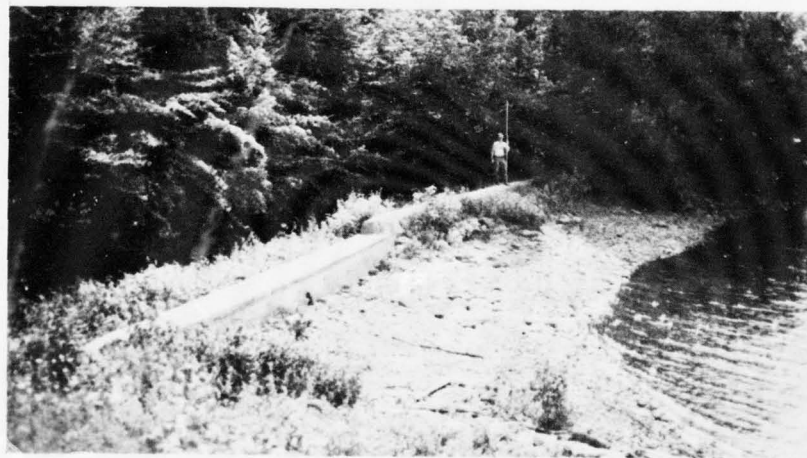
(2) Right Spillway. The approach area for the right spillway had a small amount of light brush growth (Photograph D). The concrete on both the main and auxiliary weir sections was in good condition except for one small area of disintegration about 6 inches in diameter. The right spillway discharges into the diversion channel that was excavated around the right side of the reservoir. Between the spillway weir and the discharge channel, a distance of about 20 feet, there was a considerable growth of brush (Photograph D). Farther downstream, the right spillway discharge channel is similar to the left one in that it is excavated into rock and bounded by a dry masonry wall on one side and by the hillside on the other. A number of small trees were growing in the fractures in the rock (Photograph H).

(2) Right Spillway. The light brush growing in the approach area of the right spillway is undesirable. The small area of disintegration of the concrete on the weir has not yet progressed to the extent that repairs are warranted. The growth of brush between the weir and the diversion channel is undesirable. The trees in the discharge channel could cause debris collection and a reduction in channel capacity during floods.

D. Right Spillway — View from Downstream.

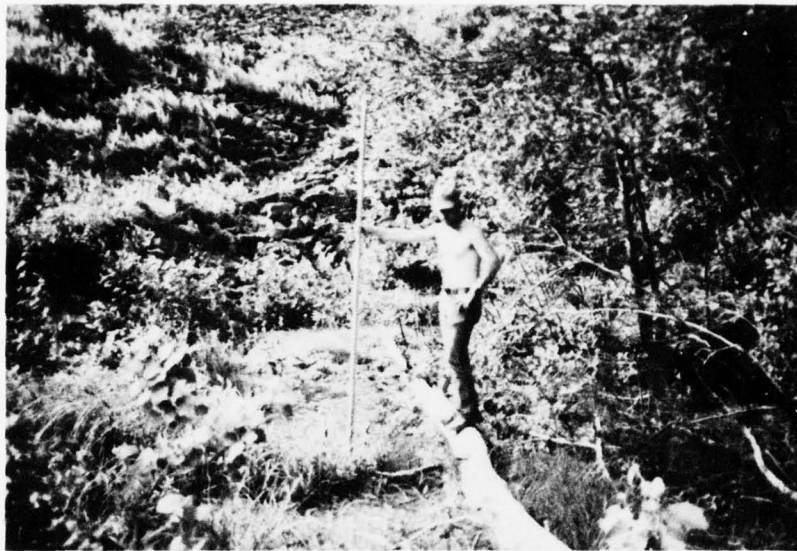
inspections since at least 1927. However, examination of available information suggests that this flow has existed since the dam was built and that the source of flow to this area is outflow from a spring located at the left abutment. Although the spring outlet could not be found in this inspection, the available information indicates that the spring was boxed in and piped through the embankment to this area. The existence of the small channel with low masonry walls that drains this area supports the conclusion. The condition of that channel, which is overgrown with weeds, shrubs, and small trees, is such that it does not drain the wet area effectively. The lack of adequate drainage causes the large wet area. This could mask the development of any uncontrolled seepage through the embankment.

E. Wet Area at Toe Near Left Abutment.

- (1) Clear spillway discharge channels of brush and trees.
- (2) Clean out the small channel that drains the wet area along the toe of the dam near the left abutment so the wet area is properly drained. Install a weir to measure outflow, monitor the area visually, and maintain records.
- (3) Make provisions, such as drains or ditches, to drain the wet area along the toe 50 feet right of the gatehouse. Measure outflow and maintain records. If conditions worsen they should be thoroughly studied and, if necessary, remedial action should be taken.
- (4) Visually monitor wet area along toe 30 feet left of gatehouse.

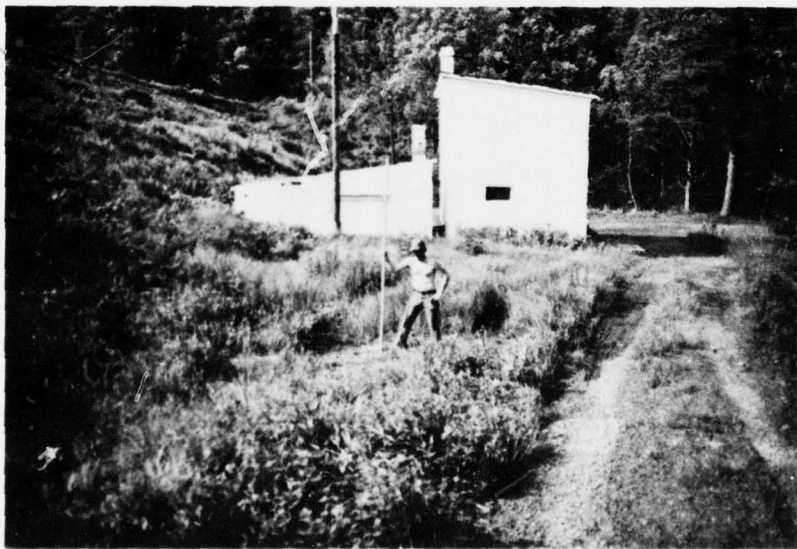
(5) The wet area along the toe 50 feet right of the gatehouse has been reported in previous inspections at least since 1934. Information in the 1914 report by the Pennsylvania Water Supply Commission indicates that the source of the water is a french drain that was constructed to convey water from a spring in the cutoff trench near the right abutment to the toe of the dam. Assuming that this is the case, the only real hazard of the wet area is that it might mask the development of any uncontrolled seepage.

F. Wet Area at Toe  
50 Feet Right of Gatehouse.

(3) Make provisions, such as drains or ditches, to drain the wet area along the toe 50 feet right of the gatehouse. Measure outflow and maintain records. If conditions worsen they should be thoroughly studied and, if necessary, remedial action should be taken.

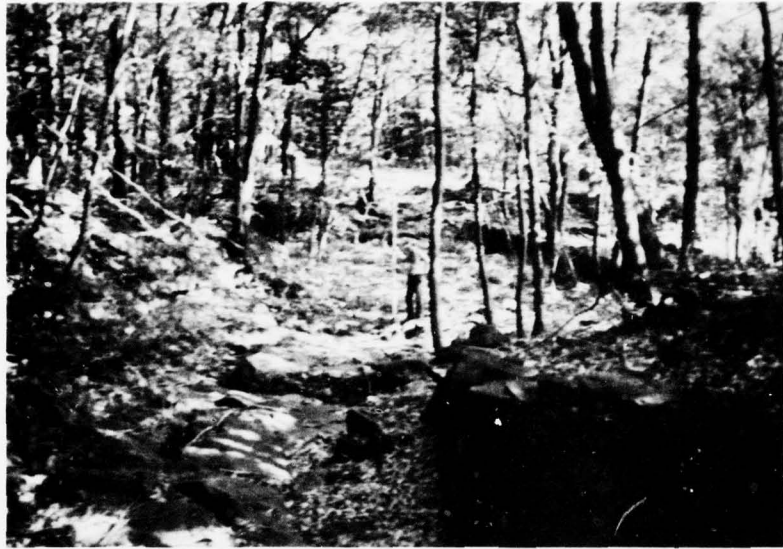
c. Visual Observations. On the date of the inspection, conditions were observed in both spillway discharge channels that would reduce the spillway capacity of Crystal Dam during a flood occurrence. A pipe bridge support was constructed near the centerline of the left spillway discharge channel about 35 feet downstream from the weir. Debris could easily become entangled on the structure and reduce the capacity of the spillway. In addition, brush was growing in the discharge channels of both spillways that would reduce the capacities of them. Another problem observed was that the high ground that separates the diversion channel and the channel of the West West Branch Schuylkill River had been excavated at one location where Crystal Run enters the diversion channel (Photograph O). Apparently, the excavation was for the purpose of installing an emergency waterline and was never backfilled. The excavated area would allow flow of water from the diversion channel into the reservoir before its design capacity would be realized. Though significant, none of the aforementioned conditions were included in the hydrologic and hydraulic analyses. The conditions can be eliminated by minor maintenance, and, in view of the great uncertainties concerning the watershed, would not have increased the accuracy of the study.

G. Left Spillway Discharge Channel.

(3) Replace or modify the pipe bridge across the left spillway so that no supports are in the spillway discharge channel.

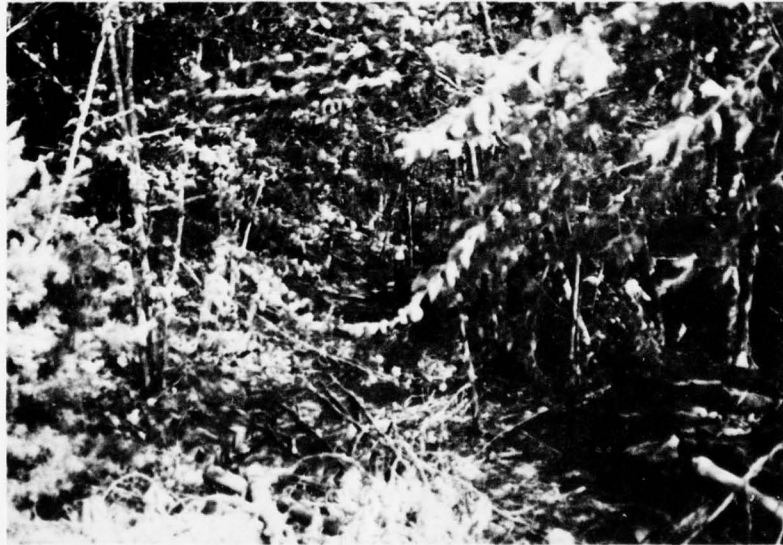
H. Right Spillway Discharge Channel.

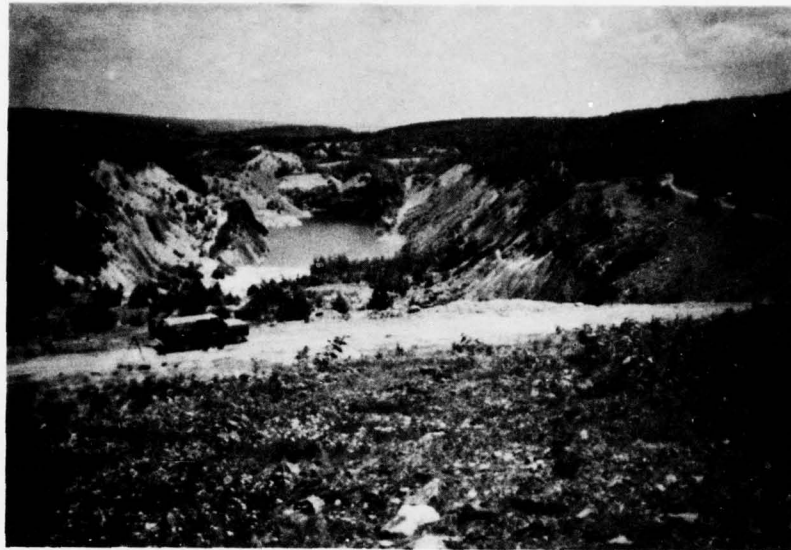
J. Strip-Mined Area of Watershed.

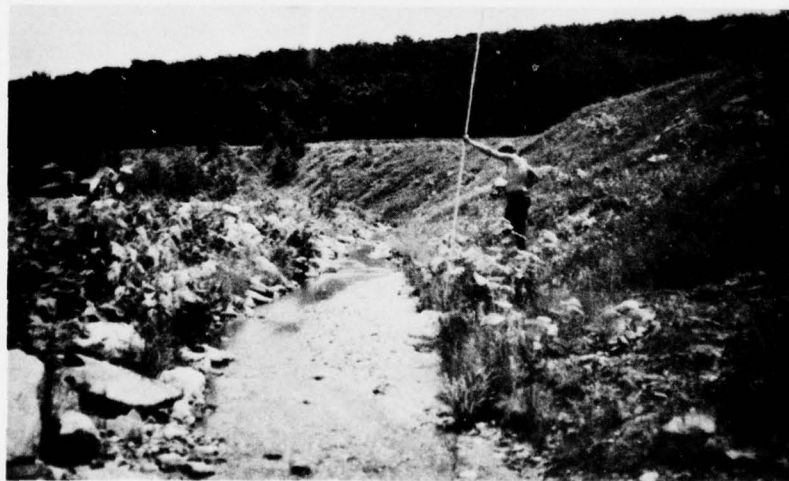
K. Flume Around Strip-Mined Area.

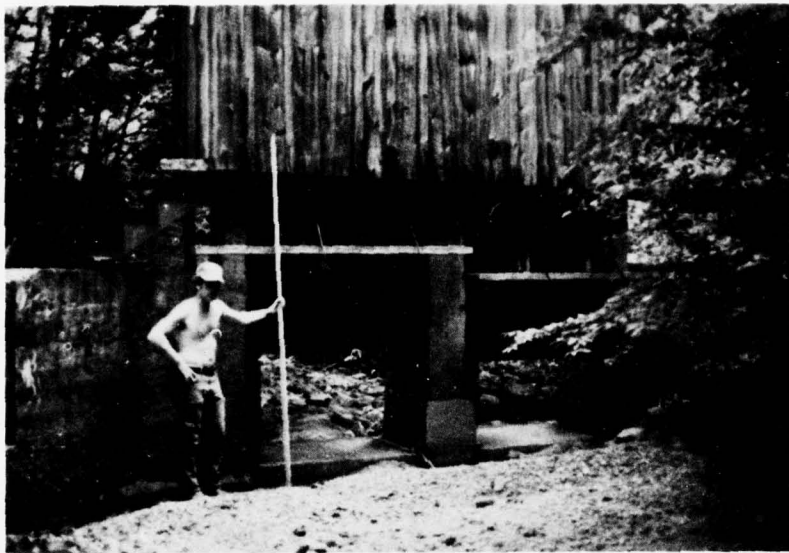
L. Right Side of Diversion Structure —  
View from Upstream.  
Diversion Channel in Background.

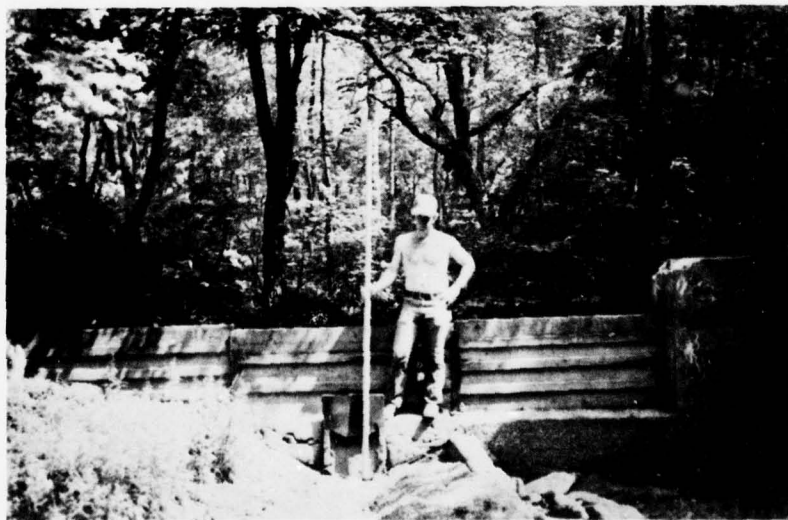
M. Left Side of Diversion Structure —  
View from Upstream.  
Original Channel of West West Branch Schuylkill River  
in Background.

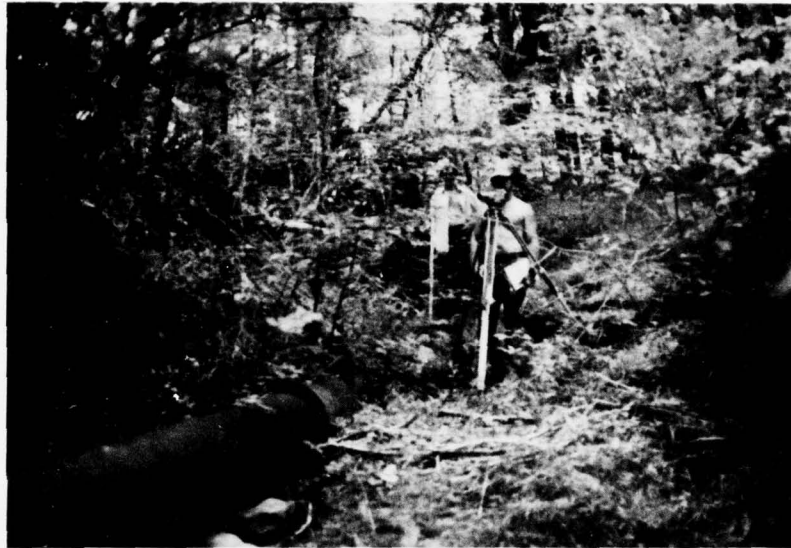
O. Excavated Area Between Diversion Channel and Original Channel of West West Branch Schuylkill River. View from Diversion Channel.

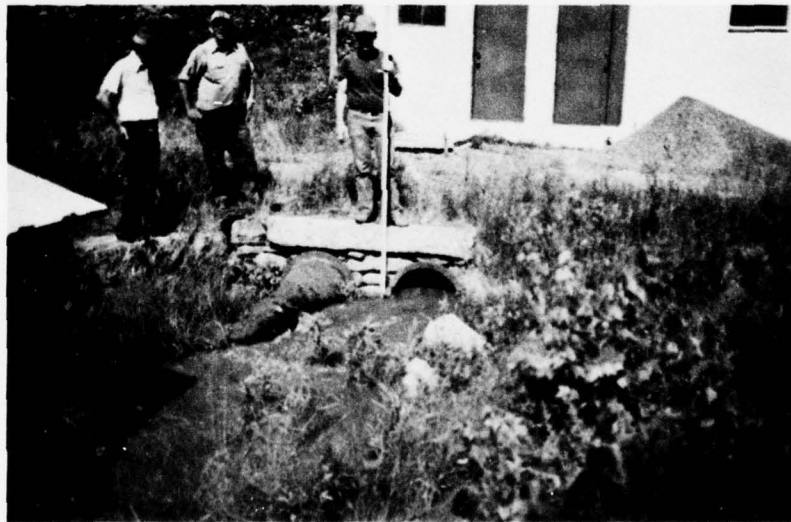
of construction used in installing the pipes. The pipes are concrete encased and were pressure tested to a head 24 times greater than the maximum head that the pipes would ever experience. Although the valve on the blowoff line opened easily, the rusted condition of the valve is unsatisfactory. Furthermore, the fact that the valve did not re-seal tightly indicates that it probably needs internal maintenance. Although probably not a serious hazard to the dam, the Owner should realize that if it were necessary to open the blowoff under emergency conditions, the force of the outflow might damage the 8-inch pressure line that crosses the outlet channel.

P. 20-Inch Blowoff During Operation.
